BOEING AEROSPACE CO HOUSTON TX SPACE DIV
SNEAK CIRCUIT ANALYSIS OF F-4C FLIGHT CONTROL SYSTEM, (U)
SEP 74 P F STOKES

D2-118545-1

Sneak Circuit Analysis of F-4C Flight Control System

SEPTEMBER, 1974
HOUSTON, TEXAS

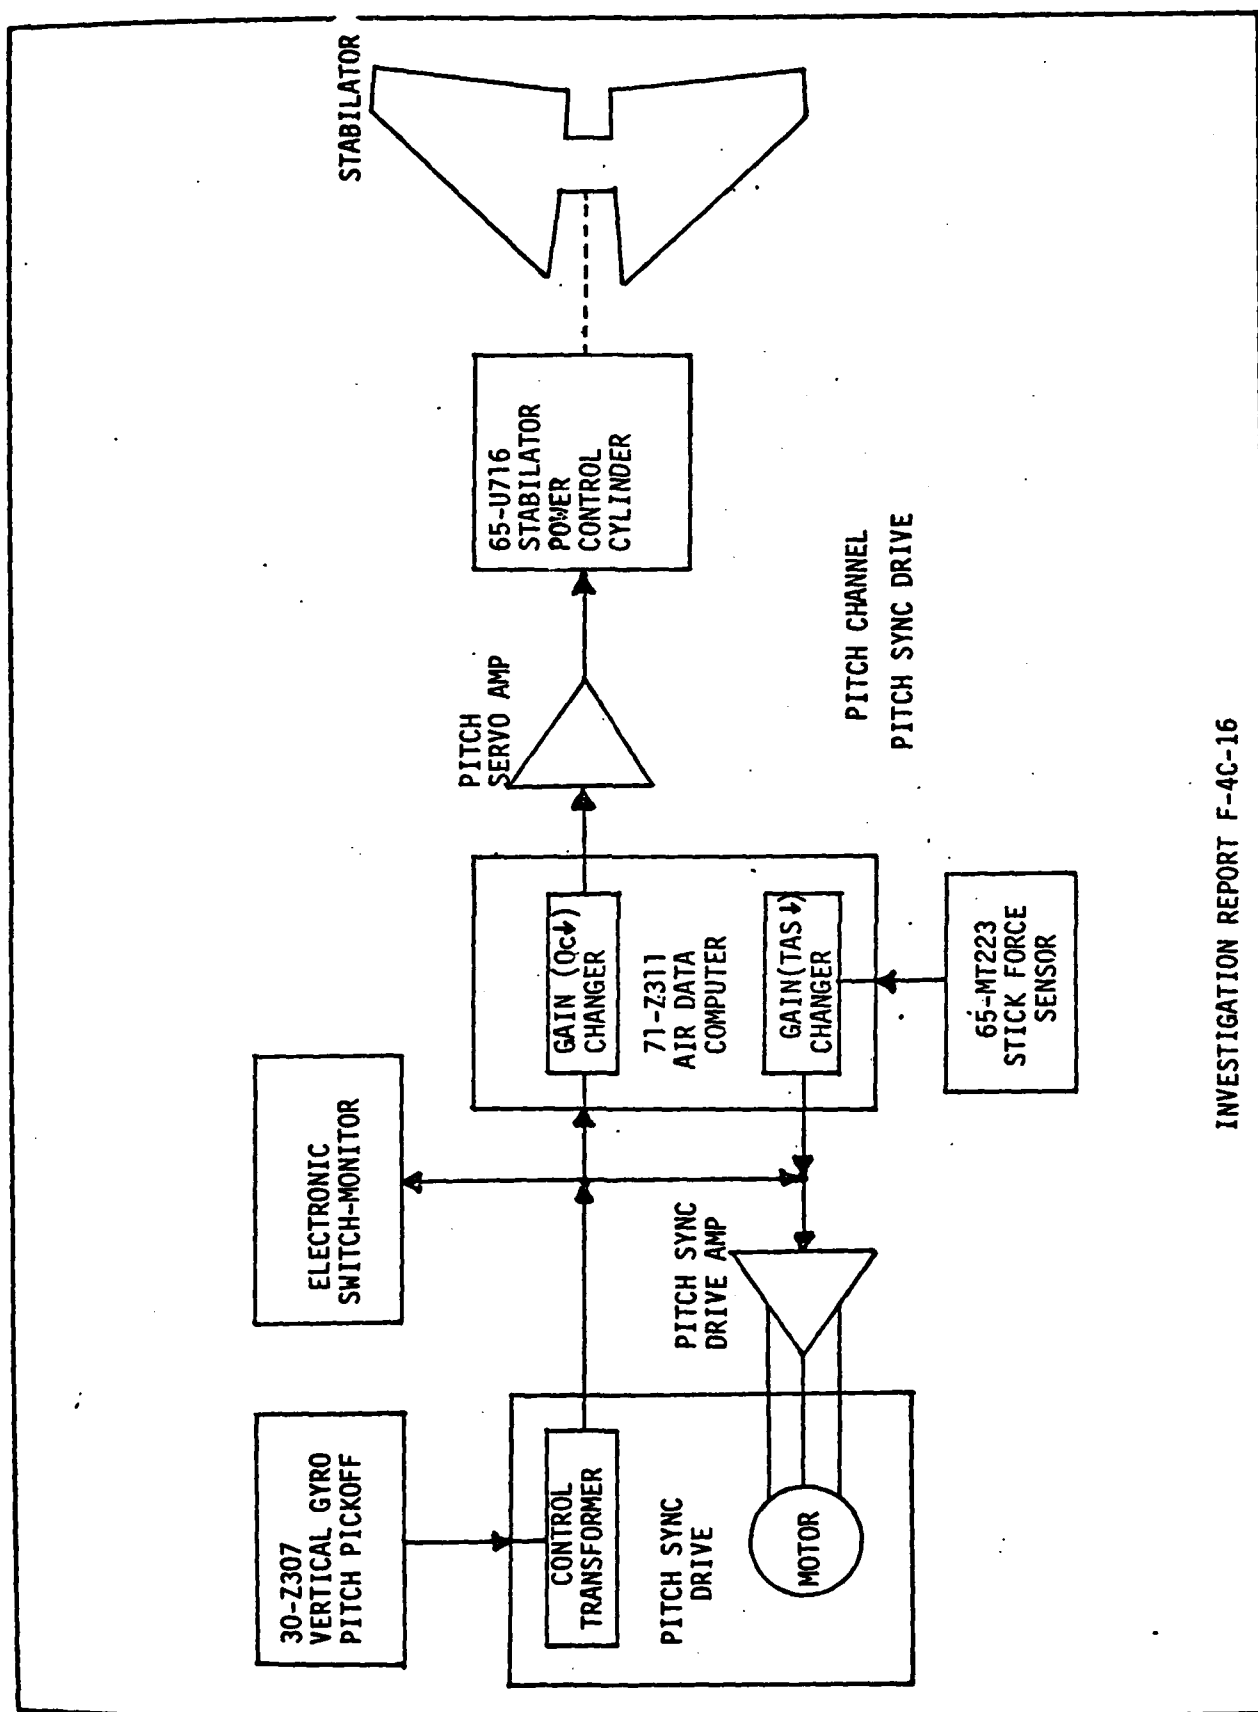
INVESTIGATION REPORT F-4C-16

The signal from the control transformer goes to the CADC for gain changing of pitch attitude. The output of the CADC goes to the Pitch Servo Amplifier. The Pitch Servo Amplifier controls stabilator movement.

The attitude at which the Pitch Sync Drive is set when the Pitch Sync Drive Amplifier is disabled, will be the only attitude the Pitch Sync Drive will hold and this attitude setting cannot be changed.

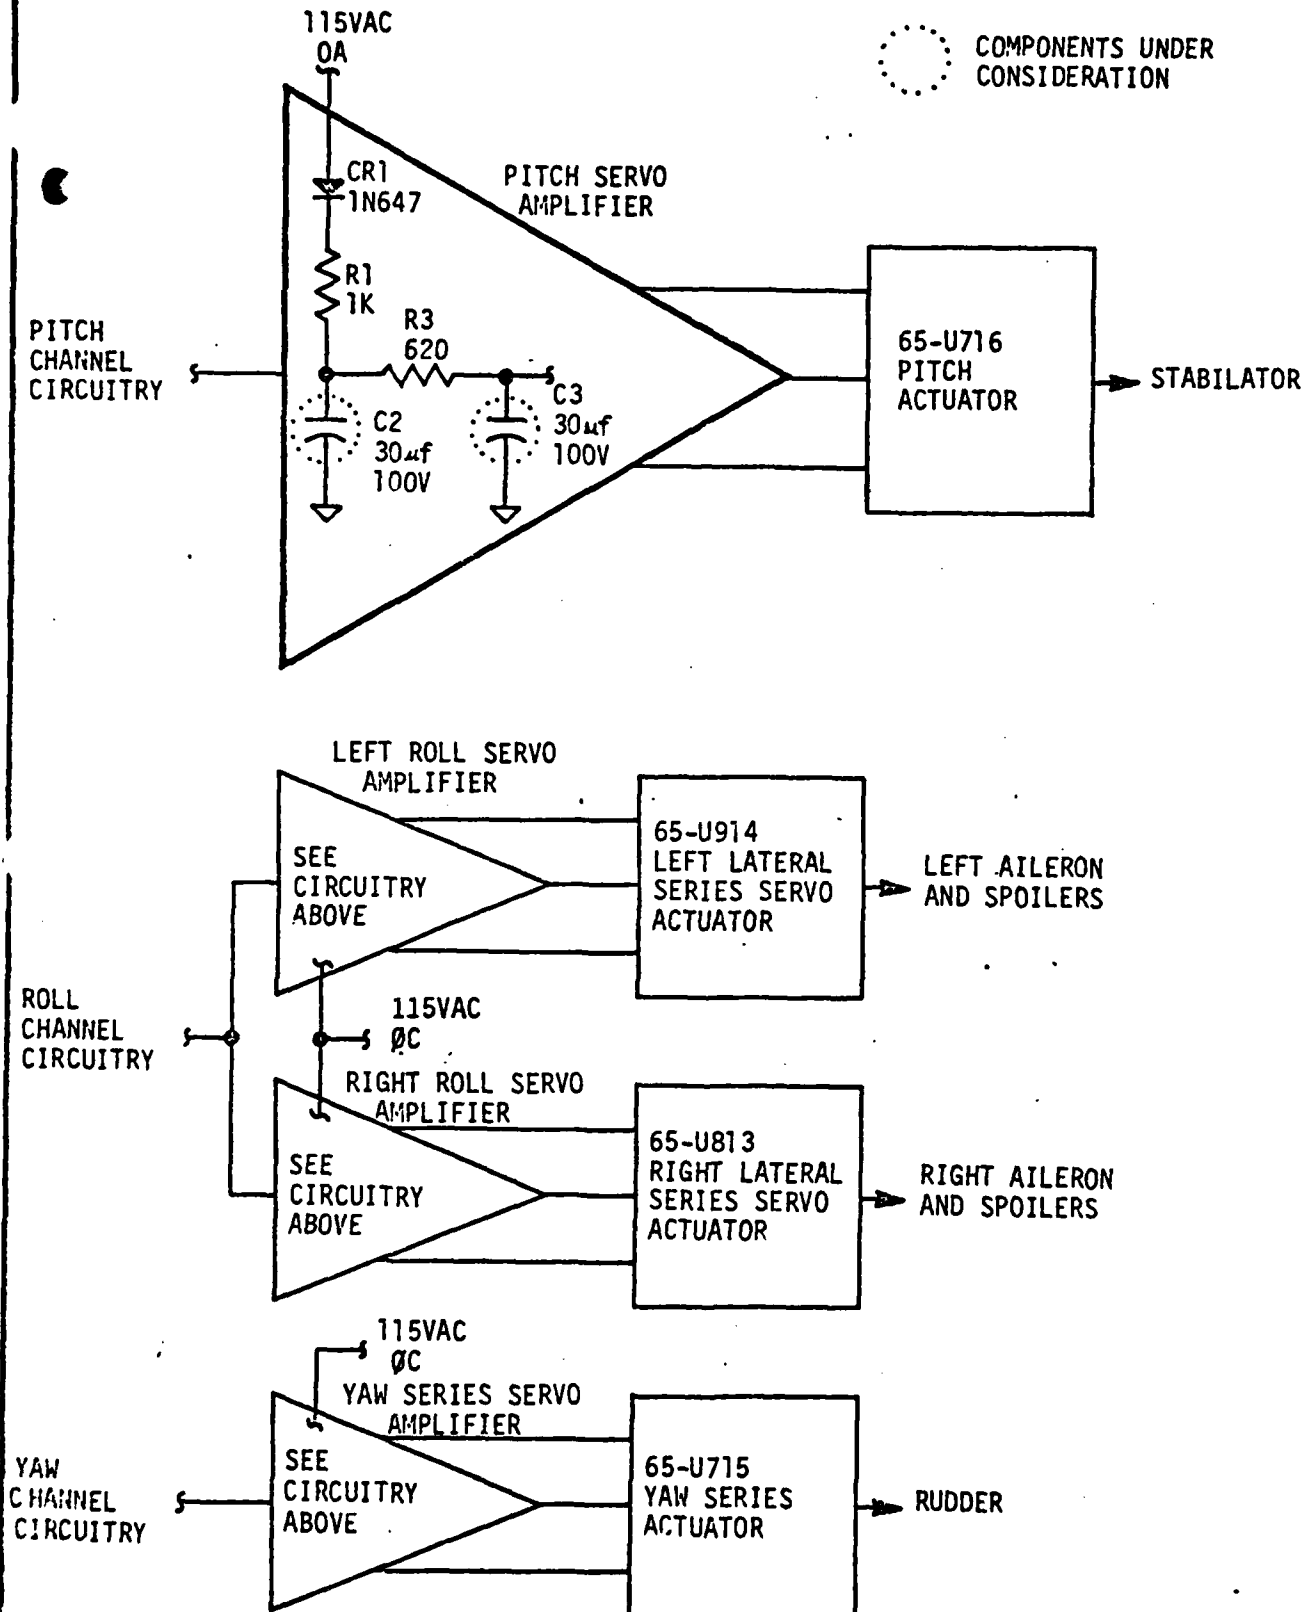
INVESTIGATION REPORT F-4C-17

Capacitors C2 or C3 in the Yaw Servo Amplifier would short the power source for the amplifier if either of them fails shorted. There would then be no AFCS control over rudder movement.

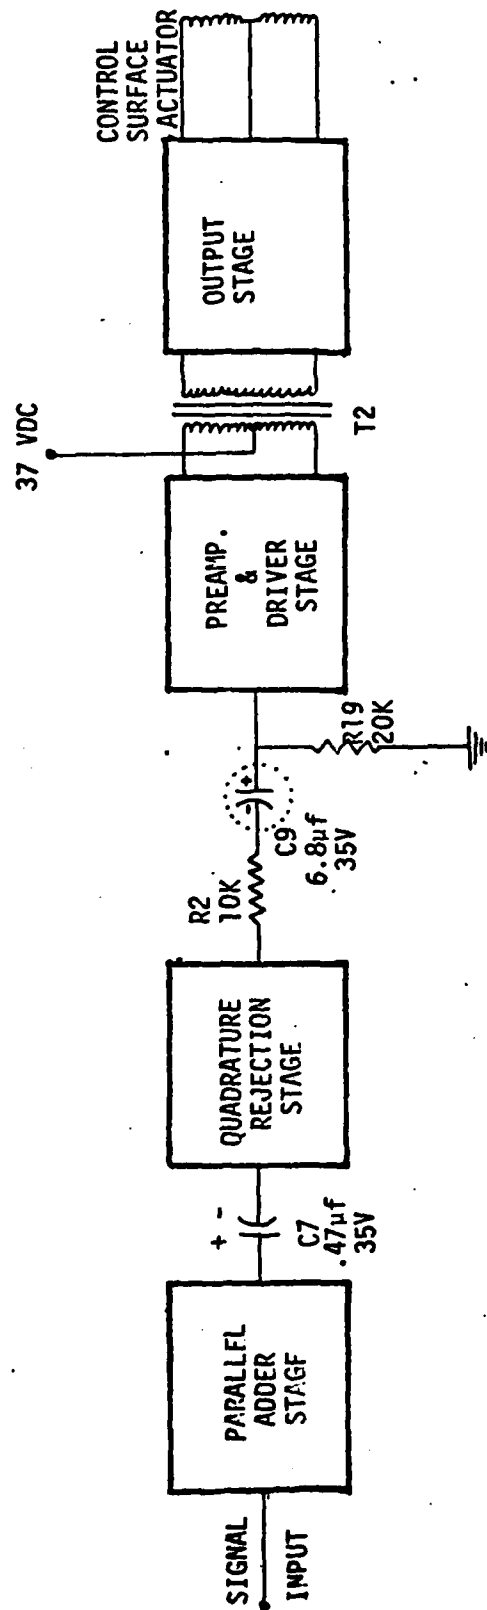
INVESTIGATION REPORT F-4C-18

If capacitor C9 in the Yaw Series Servo Amplifier fails shorted, it could cause the rudder to respond improperly to autopilot maneuvers.
